Bird Safe KC.org

2019-2023 Report

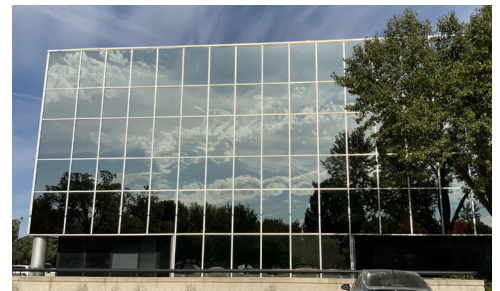
The glass of both residential and commercial buildings poses a significant risk to birds, particularly during migration (e.g., Banks 1976, Ogden 1996). Fully transparent glass with vegetation on either side can cause birds to attempt to fly “through” the building. Highly reflective glass, such as that pictured on the right, can provide a disorienting view of vegetation that, to a bird, looks real and desirable to reach for foraging or shelter. As a taxonomic group, birds existed for millions of years prior to the proliferation of glass across the planet; it is a potentially lethal barrier to which they are not accustomed. Additionally, many of our most densely populated cities are right in the middle of migratory pathways. The proximity of birds to potential window-strike zones is compounded by the fact that many species migrate at night. The illuminated glow of urban and suburban areas can disorient migrants, particularly on nights with a low cloud ceiling, causing them to descend into developed areas (Parkins et al. 2016).

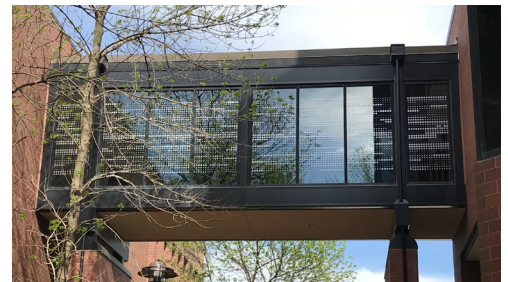
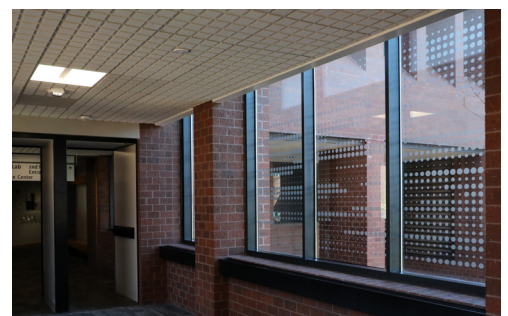
- ❁ *Window treatments:* Numerous products and artistic possibilities exist for treating problematic windows. Some building owners have chosen to engage artists to create murals on particular windows. Others chose to place patterned tape or “Zen curtains” to disrupt birds’ visual perception of a window. Most window treatments are either attractive or almost unnoticeable to the human eye. To be effective, only the most collision-prone windows need to be treated – this is why the BirdSafeKC project records not just the building that a bird hit, but the specific window or column of windows. The photos seen here are of bird strike mitigation efforts at Johnson County Community College, courtesy of Krystal Anton.

- ❁ *Lights Out:* By simply extinguishing exterior, and some interior, lighting at night – particularly during migration – you will greatly reduce the possibility that birds will be attracted to your building while in flight. See: <https://lightsouthheartland.org>

- ❁ *Closing curtains and blinds:* Window transparency and reflectivity can be mitigated by engaging interior window coverings.
- ❁ *Placement of landscaping, bird feeders and bird baths:* Birds often try to fly from one tree or fixture to one “seen” reflected in a window. Birds can reach fatal flight speeds when flying from vegetation or feeders and baths located 10-30 feet from a building, while they are unable to reach such speeds when starting from trees and shrubs planted close to buildings.

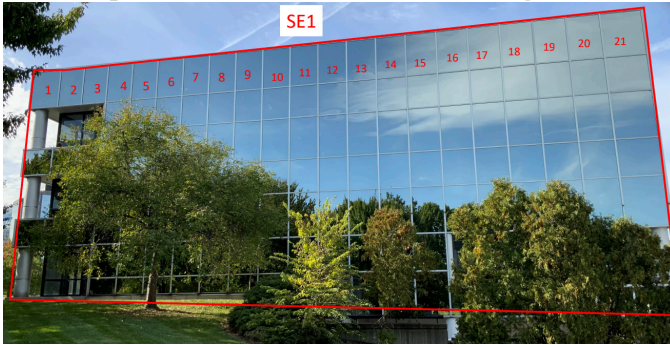
The ultimate goal of BirdSafeKC is to treat high-risk windows to reduce strikes. Therefore, an important part of the data is the section of the building where the most strikes occur, along with window column numbers (see photo at left for example). In all of the following tables, windows where three or more carcasses were found during one season, or more than ten across all seasons, are highlighted in red.
