Bird Safe KC.org

# 2019-2022 Report

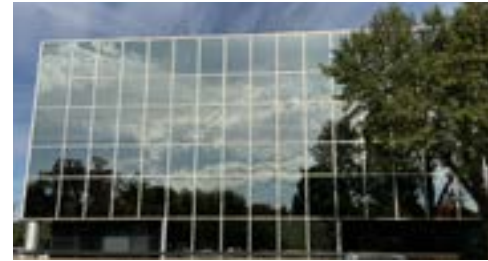
The glass of both residential and commercial buildings poses a significant risk to birds, particularly during migration (e.g., Banks 1976, Ogden 1996). Fully transparent glass with vegetation on either side can cause birds to attempt to fly “through” the building. Highly reflective glass, such as that pictured on the right, can provide a disorienting view of vegetation that, to a bird, looks real and desirable to reach for foraging or shelter. As a taxonomic group, birds existed for millions of years prior to the proliferation of glass across the planet; it is a potentially lethal barrier to which they are not accustomed. Additionally, many of our most densely populated cities are right in the middle of migratory pathways. The proximity of birds to potential window-strike zones is compounded by the fact that many species migrate at night. The illuminated glow of urban and suburban areas can disorient migrants, particularly on nights with a low cloud ceiling, causing them to descend into developed areas (Parkins et al. 2016).

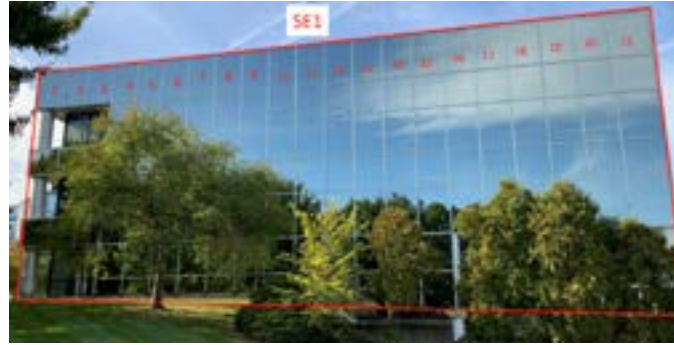
The ultimate goal of BirdSafeKC is to treat high-risk windows to reduce strikes. Therefore, an important part of the data is the section of the building where the most strikes occur, along with window column numbers (see photo at left for example). In all of the following tables, windows where three or more carcasses were found during one season, or more than ten across all seasons, are highlighted in red.
